DEPARTMENT OF TRANSPORTATION**DIVISION OF ENGINEERING SERVICES**

Quality Assurance and Source Inspection

Contract #: 04-0120F4Cty: SF/ALA Rte: 80 PM: 13.2/13.9File #: 69.28**WELDING INSPECTION REPORT****Resident Engineer:** Pursell, Gary**Address:** 333 Burma Road**City:** Oakland, CA 94607**Report No:** WIR-013250**Date Inspected:** 28-Mar-2010**Project Name:** SAS Superstructure**OSM Arrival Time:** 700**Prime Contractor:** American Bridge/Fluor Enterprises, a JV**OSM Departure Time:** 1900**Contractor:** Zhenhua Port Machinery Company, Ltd (ZPMC), Changxing Island **Location:** Shanghai, China**CWI Name:** Zhao Chen Sun**CWI Present:** Yes No**Inspected CWI report:** Yes No N/A**Rod Oven in Use:** Yes No N/A**Electrode to specification:** Yes No N/A**Weld Procedures Followed:** Yes No N/A**Qualified Welders:** Yes No N/A**Verified Joint Fit-up:** Yes No N/A**Approved Drawings:** Yes No N/A**Approved WPS:** Yes No N/A**Delayed / Cancelled:** Yes No N/A**Bridge No:** 34-0006**Component:** Tower Trial Assembly**Summary of Items Observed:**

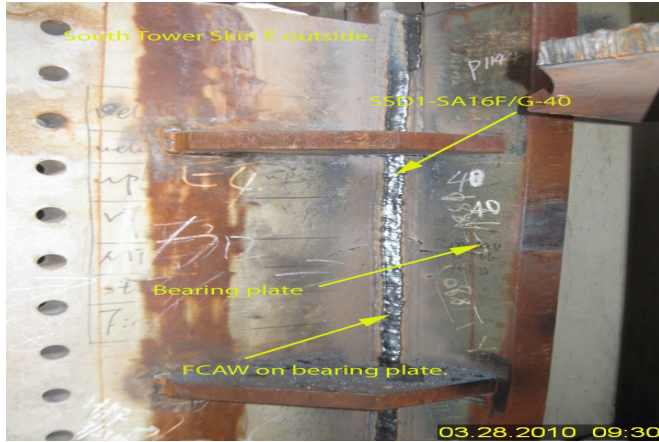
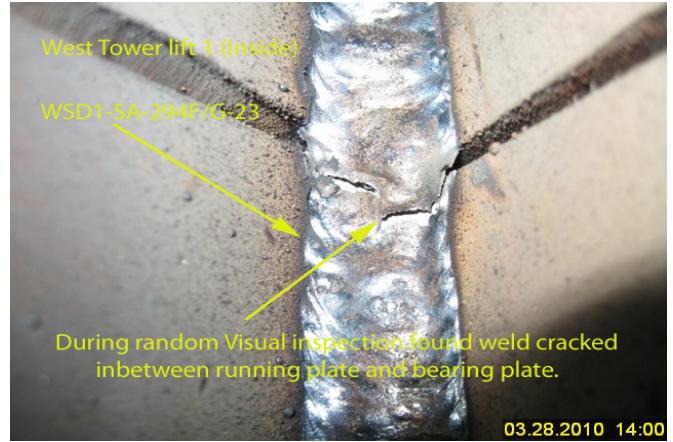
During random Visual inspection This QA Inspector observed, inside the West tower lift 1 bearing plate welding found porosity at 7 locations in one weld. Weld joint identified as WSD1-SA294F/G-17. And weld cracked found in between running plate and bearing plate weld. Weld joint identified as WSD1-SA294F/G-23. For more information see below attach photos.
